PTPD ~~REDACTED~~-78-18  
AFPEA PROJECT NO. 77-P7-48

Final rept.  
Dec 77-Apr 78

TEST AND EVALUATION OF THE BARE BASE  
GENERAL PURPOSE SHIPPING AND STORAGE CONTAINERS

AFALD/PTPD  
AIR FORCE PACKAGING EVALUATION AGENCY  
Wright-Patterson AFB OH 45433

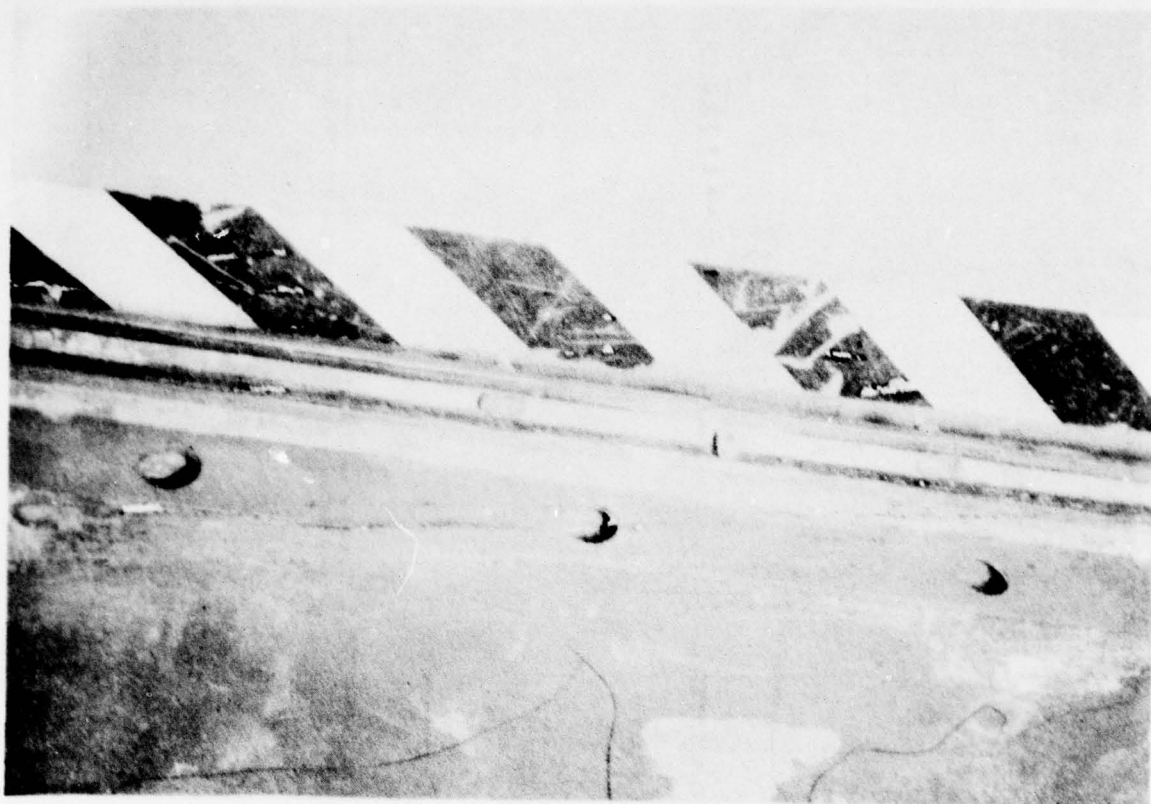
FIGURE 5. GASKET DIRT ACCUMULATION

Each container arrived with a large quantity of dirt on the gasket and the tops unbolted. Figure 5 indicates the amount of dirt on one gasket.

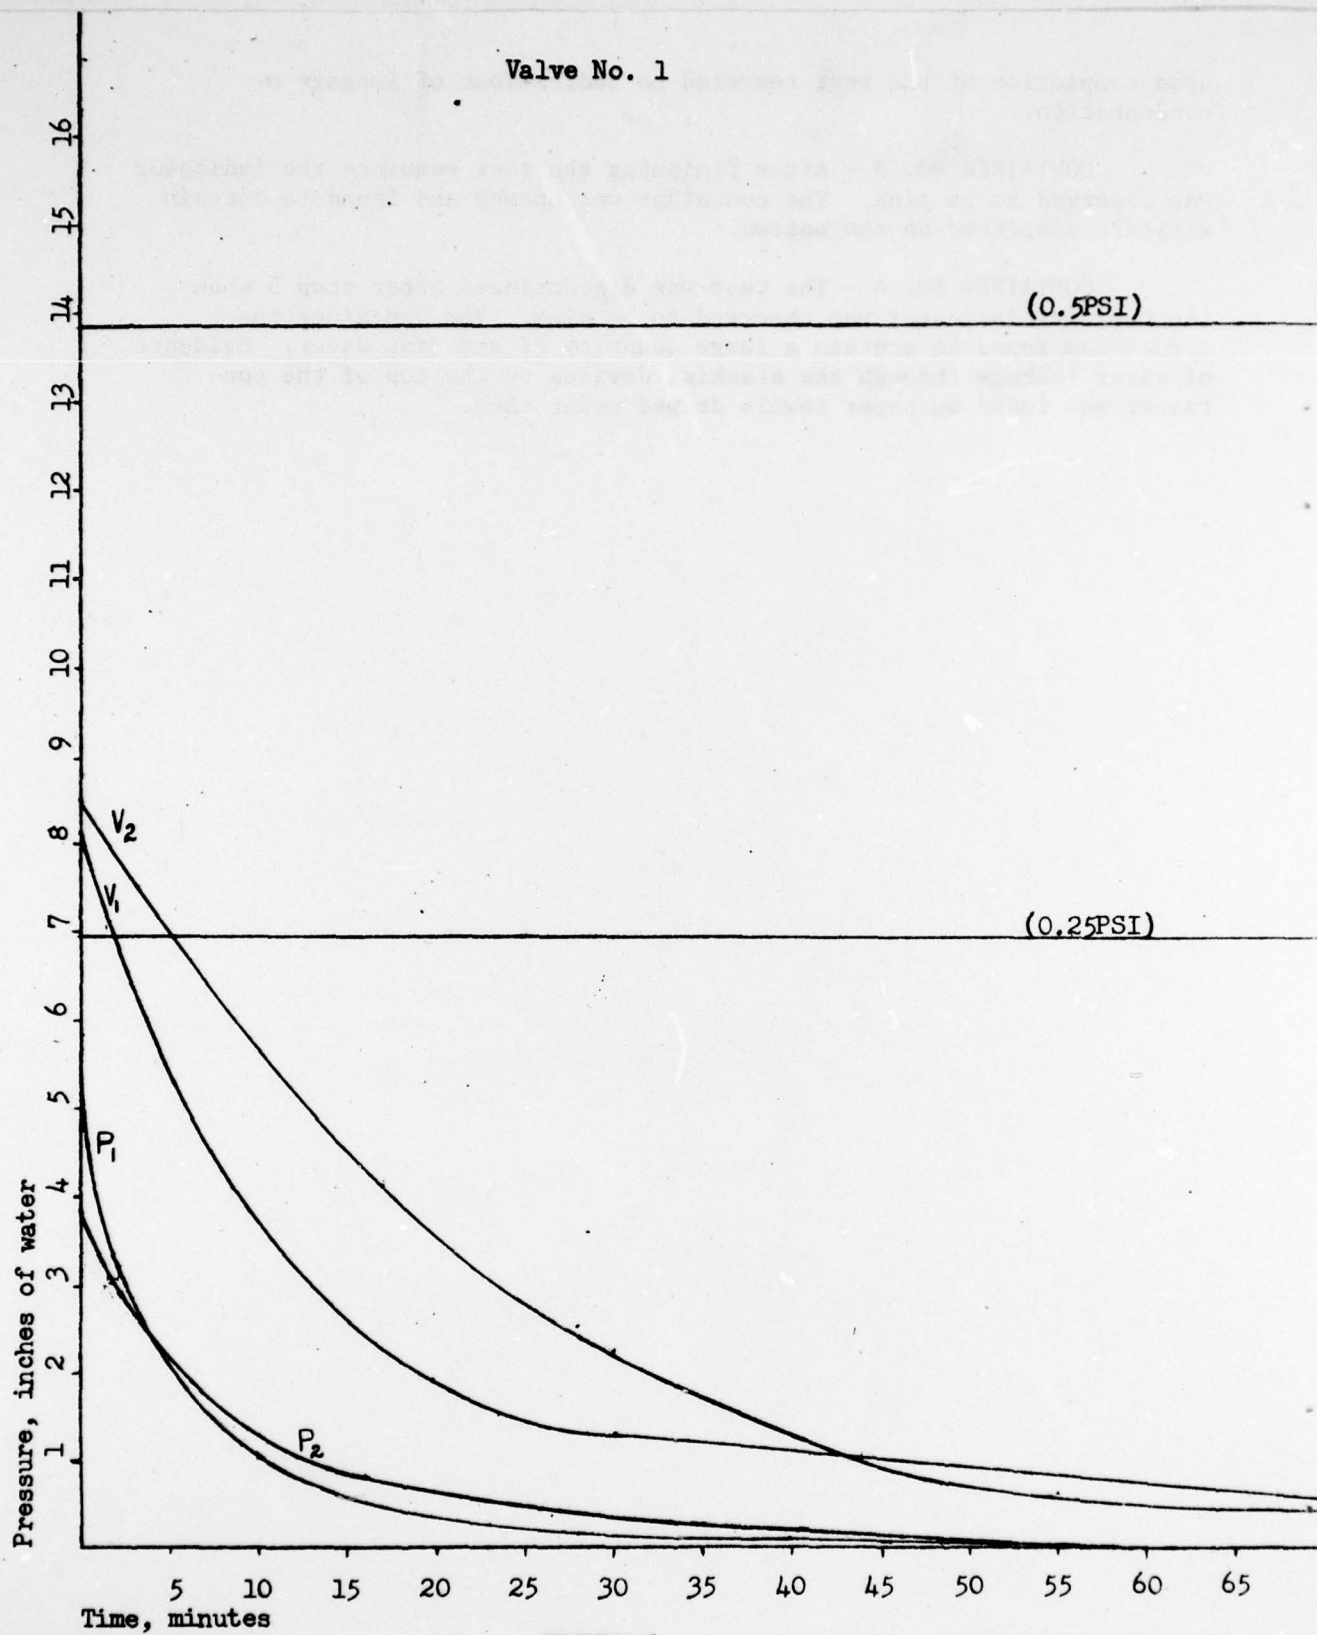
FIGURE 6

TEST-1A. Performances of the pressure relief valves are depicted in Figures 6 to 9. In each case, the test set-up was tested with soap bubble solution to assure the only air path was through the relief valve.

VALVE NO. 1 PRESSURE CHARACTERISTICS IN A 1.3 FT<sup>3</sup> CONTAINER

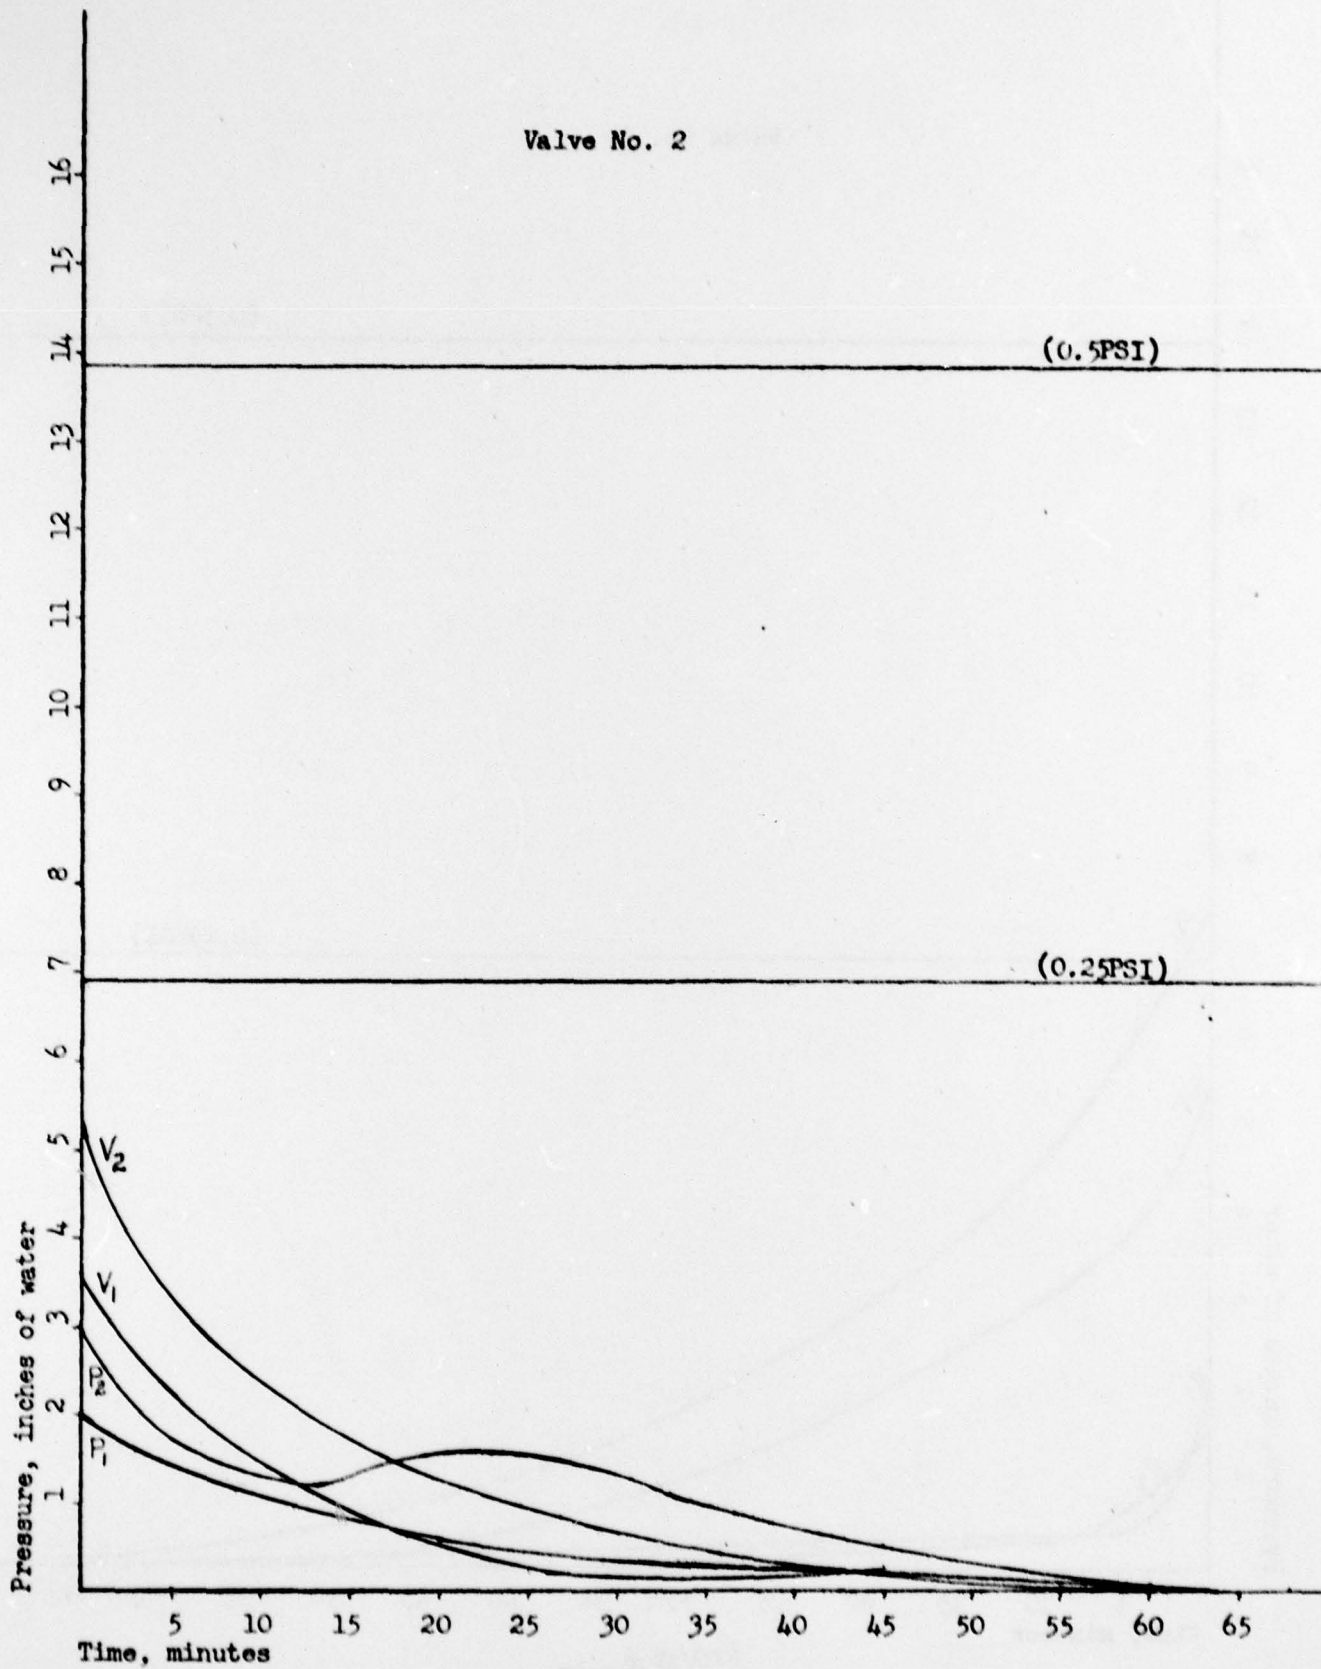
FIGURE 7

VALVE NO. 2 PRESSURE CHARACTERISTICS IN A 1.3 FT<sup>3</sup> CONTAINER

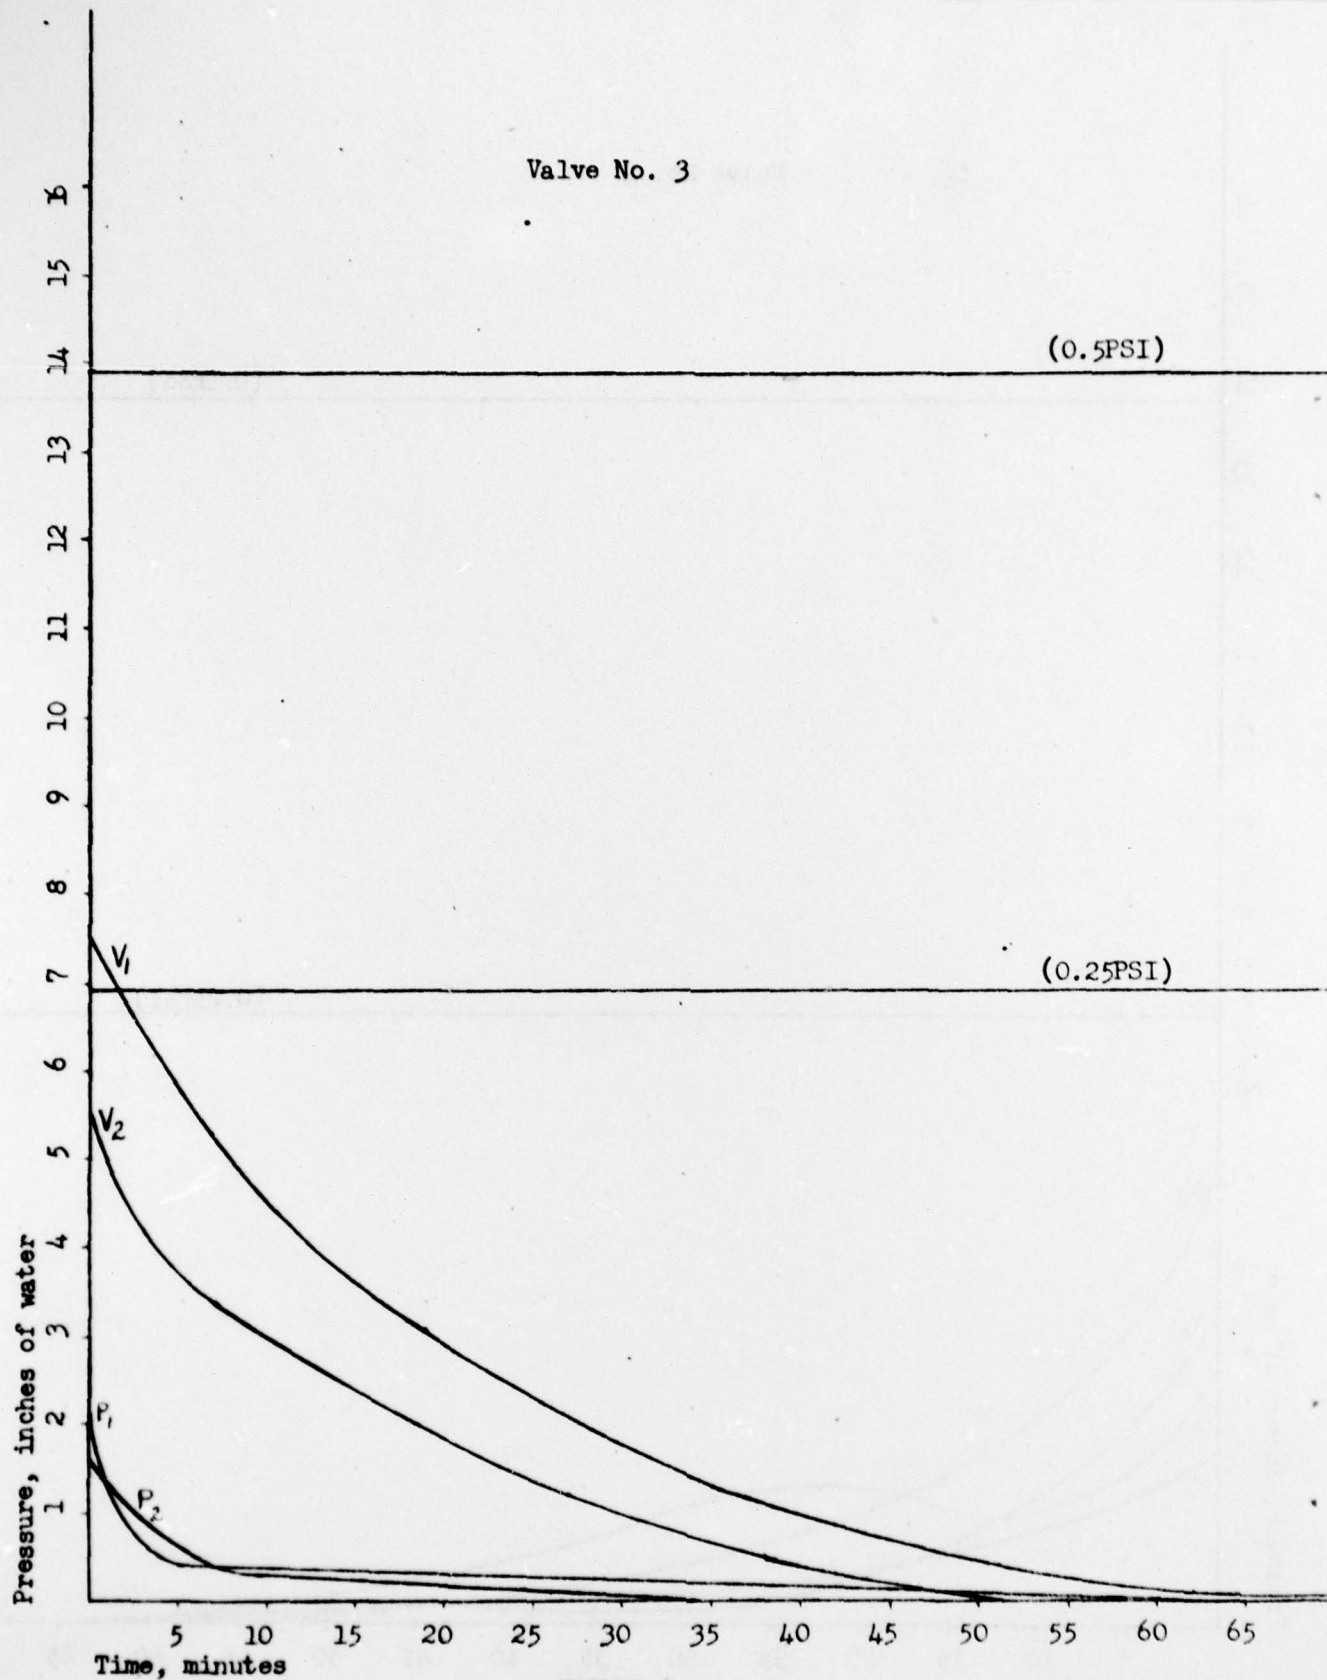
FIGURE 8

VALVE NO. 3 PRESSURE CHARACTERISTICS IN A 1.3 FT<sup>3</sup> CONTAINER

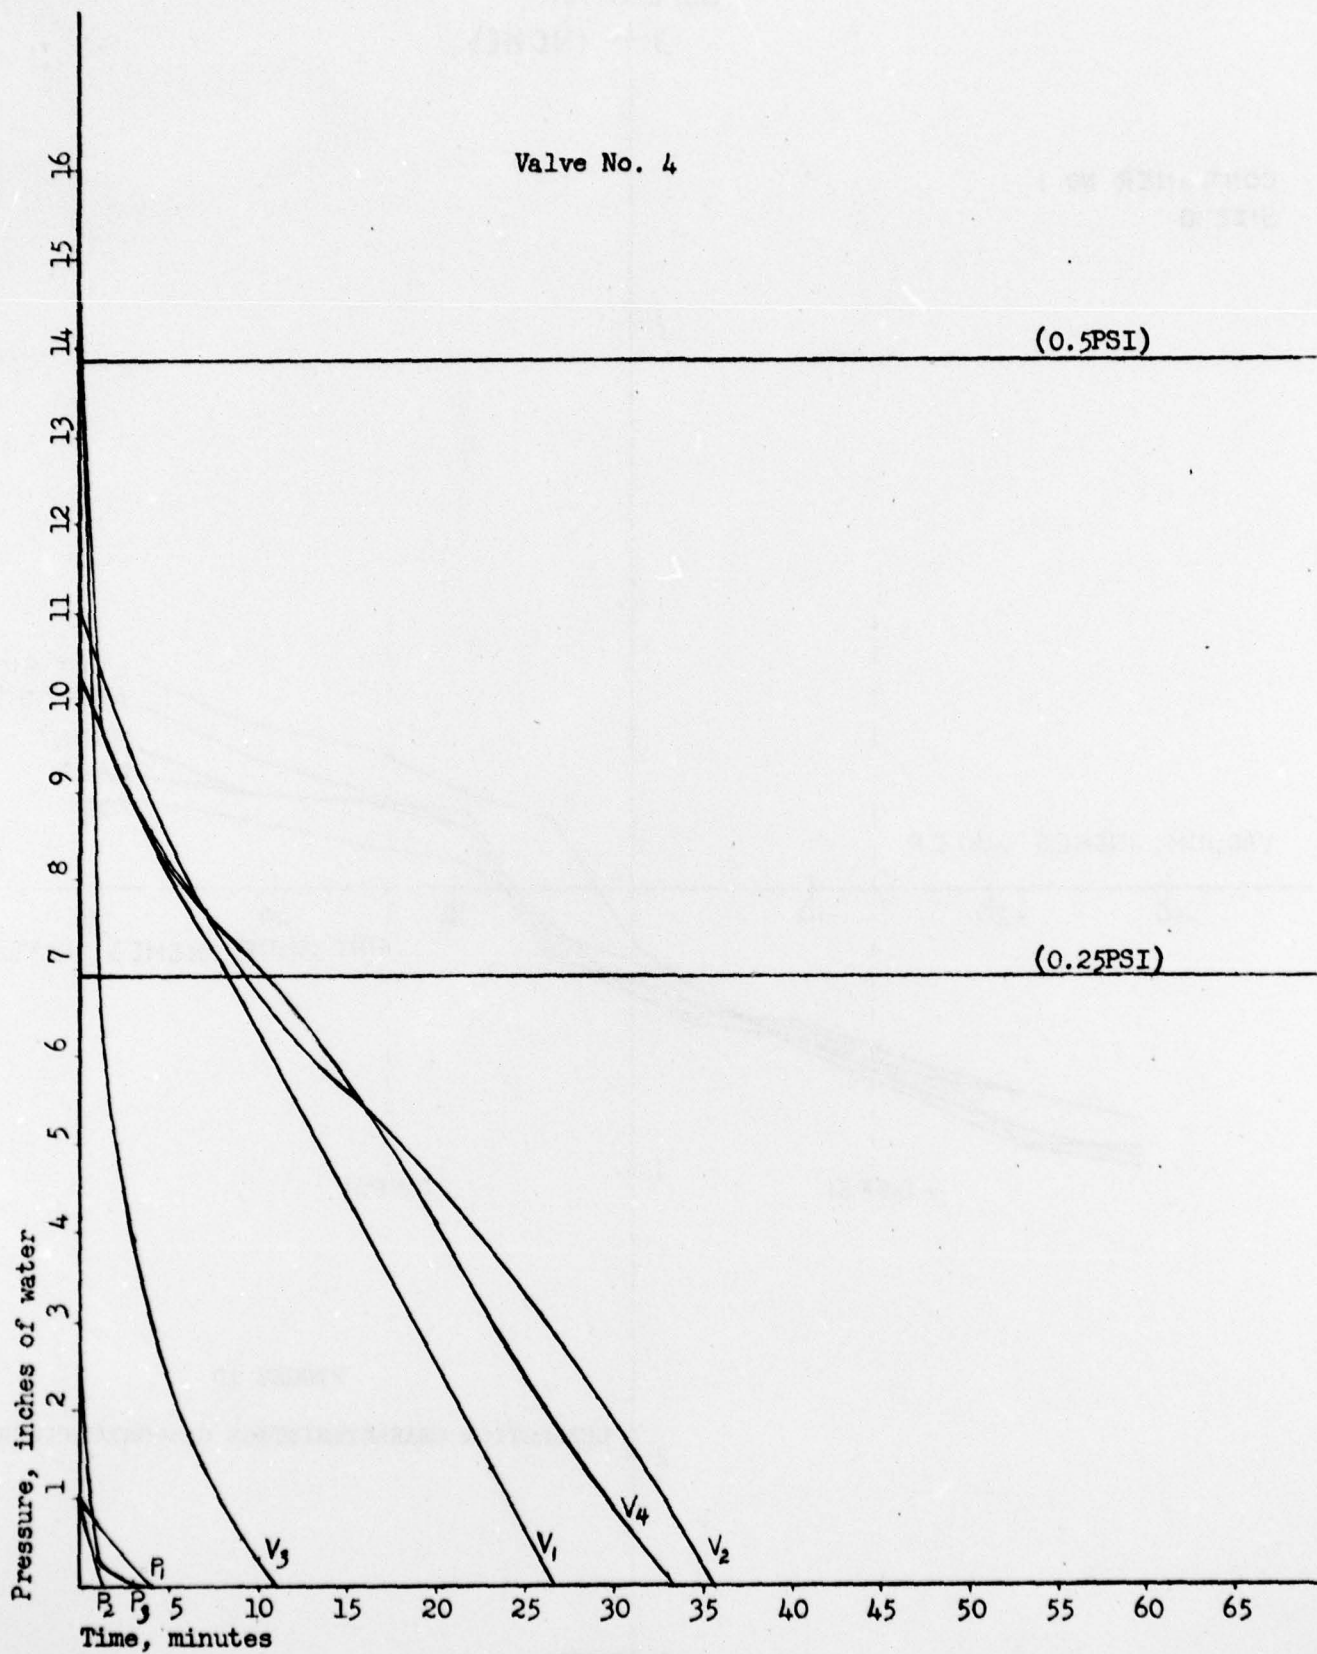
FIGURE 9

VALVE NO. 4 PRESSURE CHARACTERISTICS IN A 1.3 FT<sup>3</sup> CONTAINER

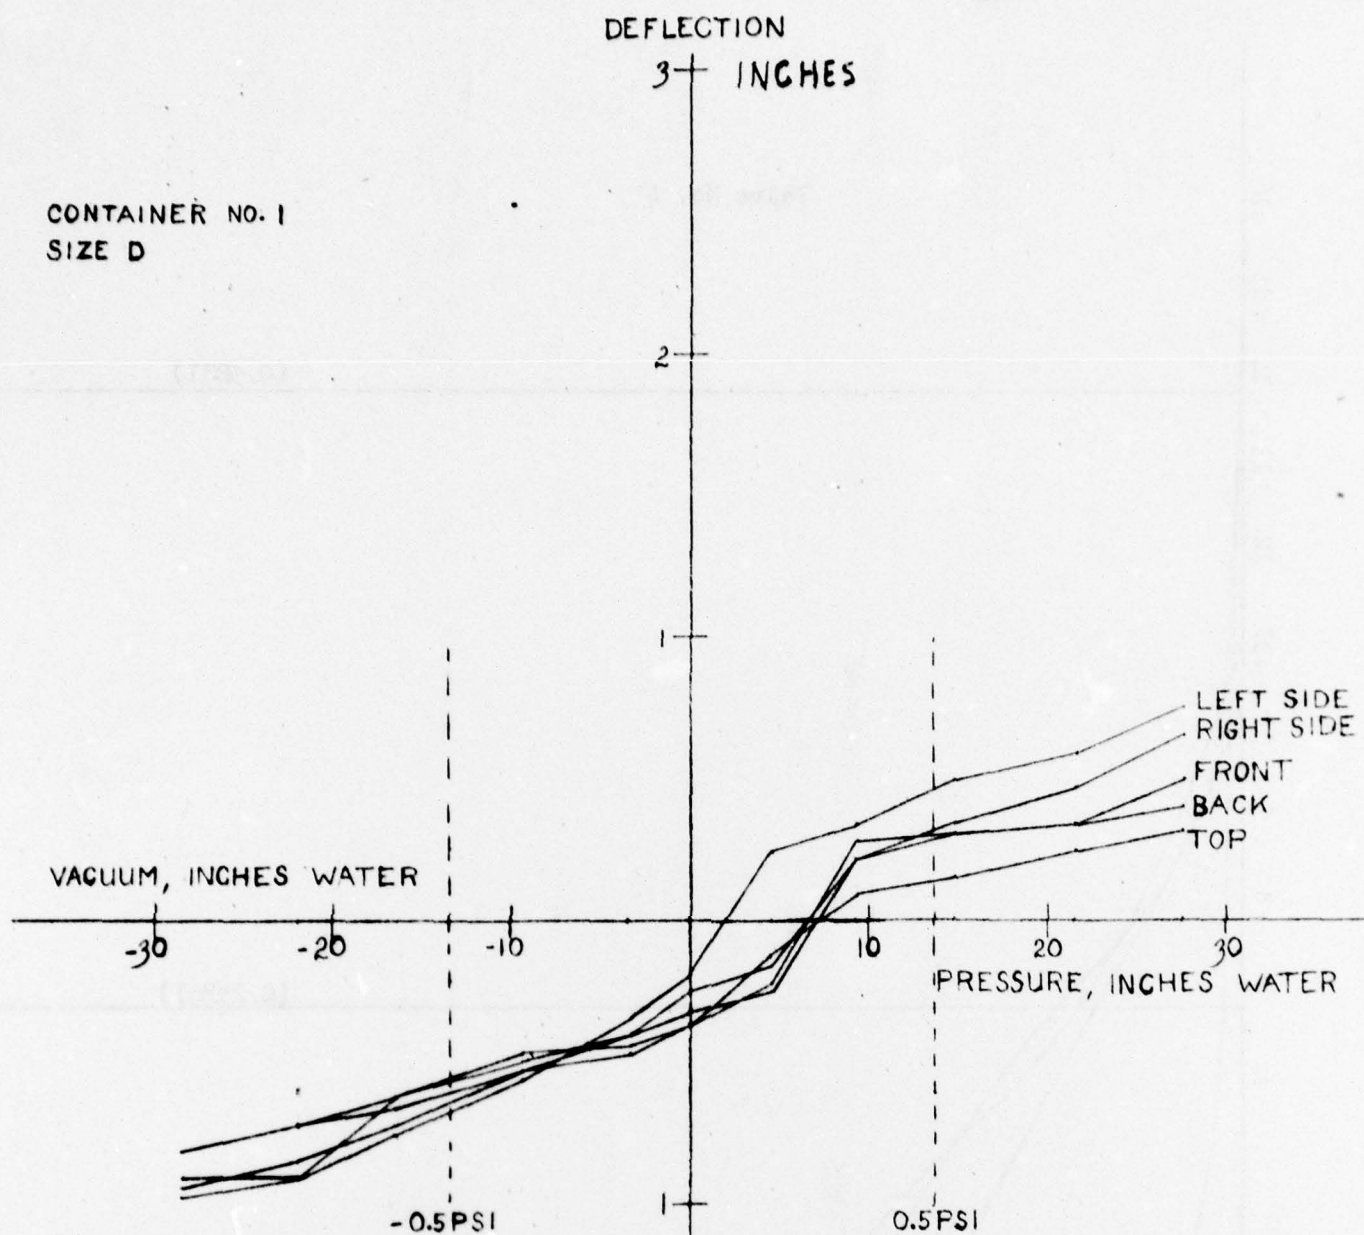
FIGURE 10

TEST-1B. In each case, the container was torqued to 40 in-lbs prior to testing and then further tightening was applied to those bolts near areas of leakage indicated by the soap bubble test. All containers required some additional tightening to slow or stop leakage enough to measure deflection. The containers deformation at the center for each wall is plotted as a function of pressure in Figures 10 to 13.

DEFLECTION CHARACTERISTICS OF CONTAINER NO. 1

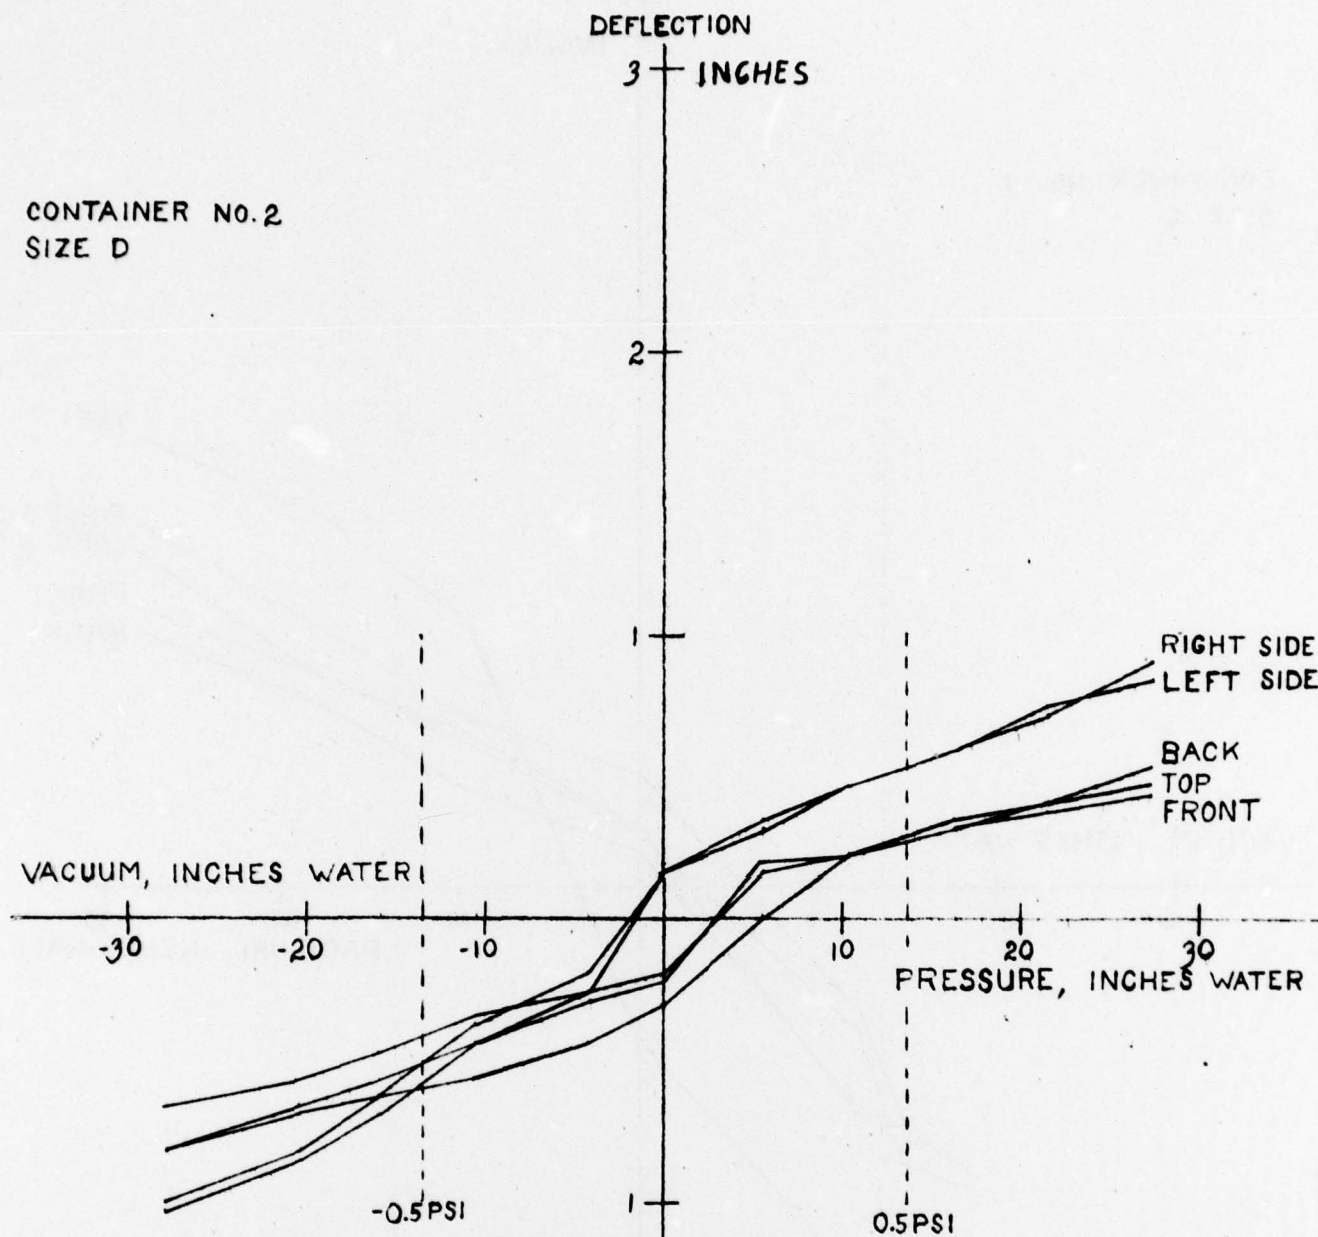
FIGURE 11

DEFLECTION CHARACTERISTICS OF CONTAINER NO. 2

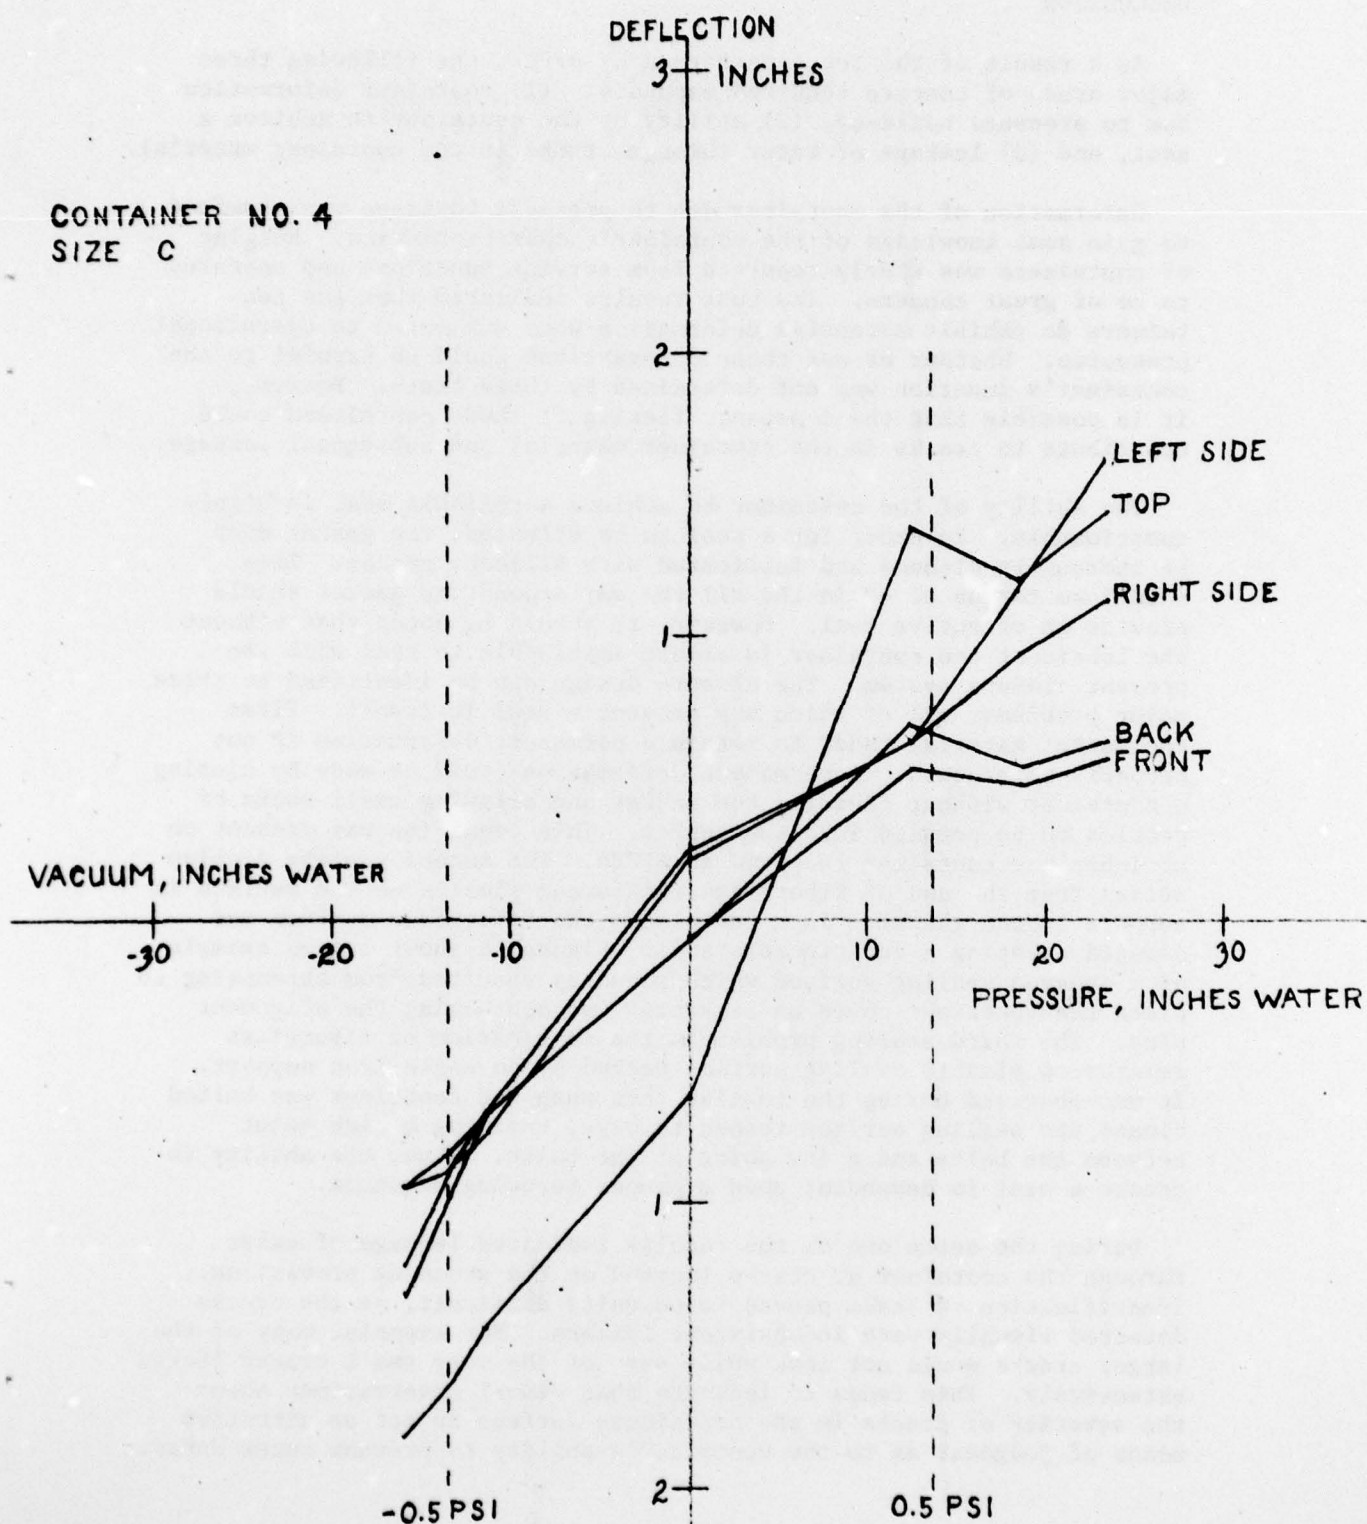
FIGURE 13

DEFLECTION CHARACTERISTICS OF CONTAINER NO. 4

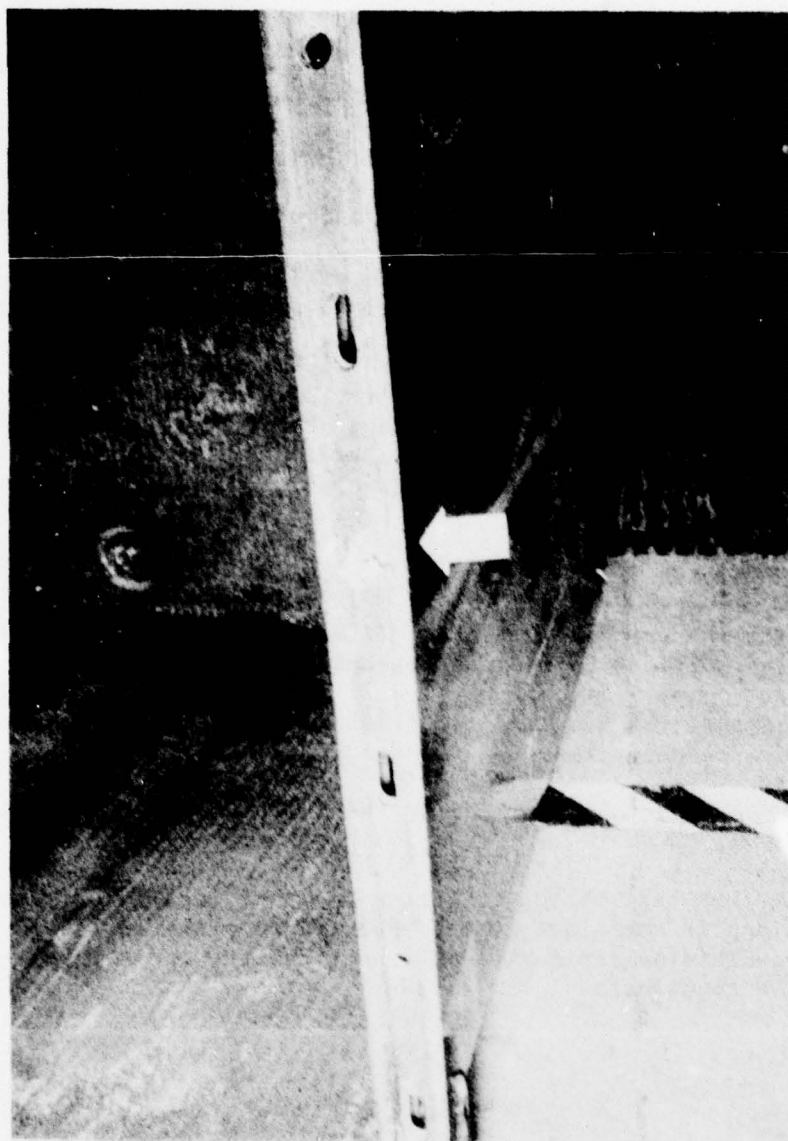
During the tests one of the results indicated leakage of water through the container at cracks located on the stacking provisions. Identification of leaks proved to be quite difficult, as the cracks detected visually were inconsistent leakers. For example, many of the larger cracks would not leak while some of the very small cracks leaked extensively. This tends to indicate that visual observations about the severity of cracks in the containers surface is not an effective means of judgment as to the container's ability to prevent water entry.

FIGURE 14. CHIPPED FIBERGLASS SEALING SURFACE

1. Investigate the feasibility of filling in the undersides of the stacking provisions to prevent leakage due to stacking damage.
2. Investigate the feasibility of making these containers into free breathers reducing side and top deformations.
3. Place an additional marking on the cover indicating location of alignment holes.
4. WR-ALC/DSP take action to determine if pallet space is used efficiently and if container geometry restricts proper usage of container cube. This determination must consider the items intended to be used in these containers.
